GIS Evaluation of the Impacts on the Built and the 'Natural' Environment of the 11 March 2011 Tsunami in Rikuzentakata, Iwate Prefecture, Japan

Christopher Gomez, Patrick Wassmer, Claire Kain, Marie de Villiers, Kelli Campbell, Stephen Ward, Arash Moghaddam

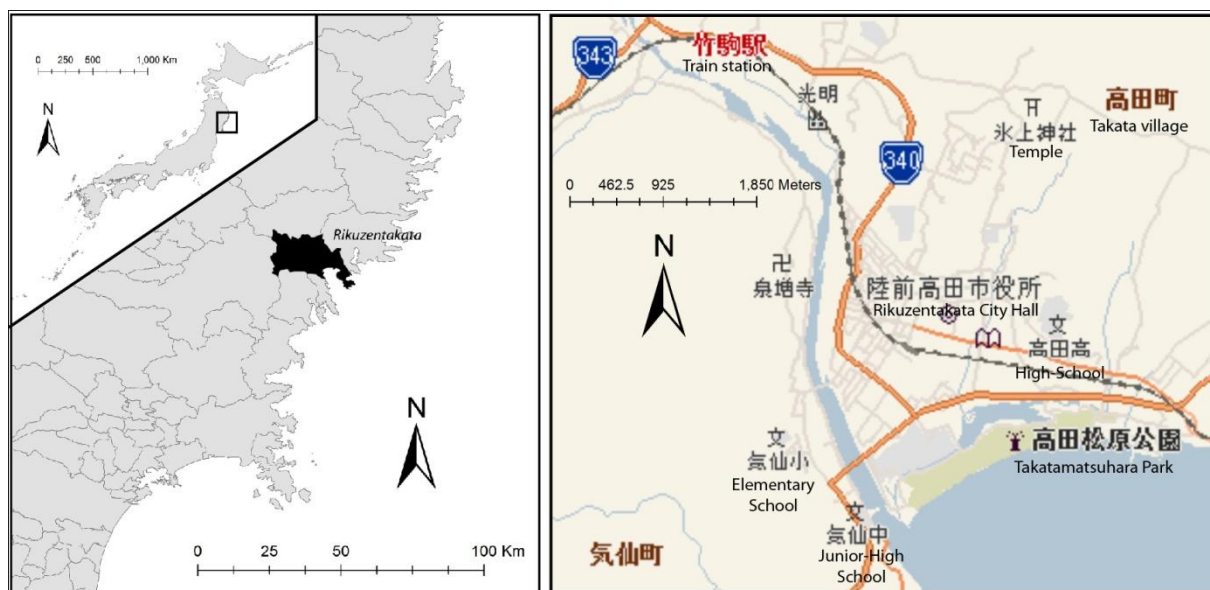
Fig.1 Location of the municipality of Rikuzentakata and distribution of the major public constructs and communication at the study location.

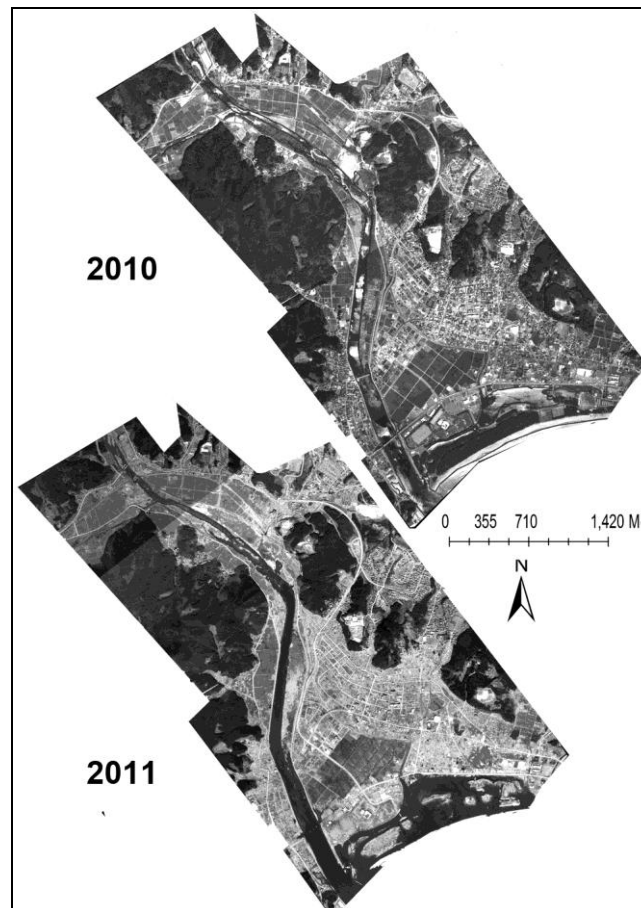
Fig. 3 The 2010 Geoeye imagery and the 2011 aerial photographs mounted, orthorectified and georeferenced for the area of Rikuzentakata and the Kesen River.

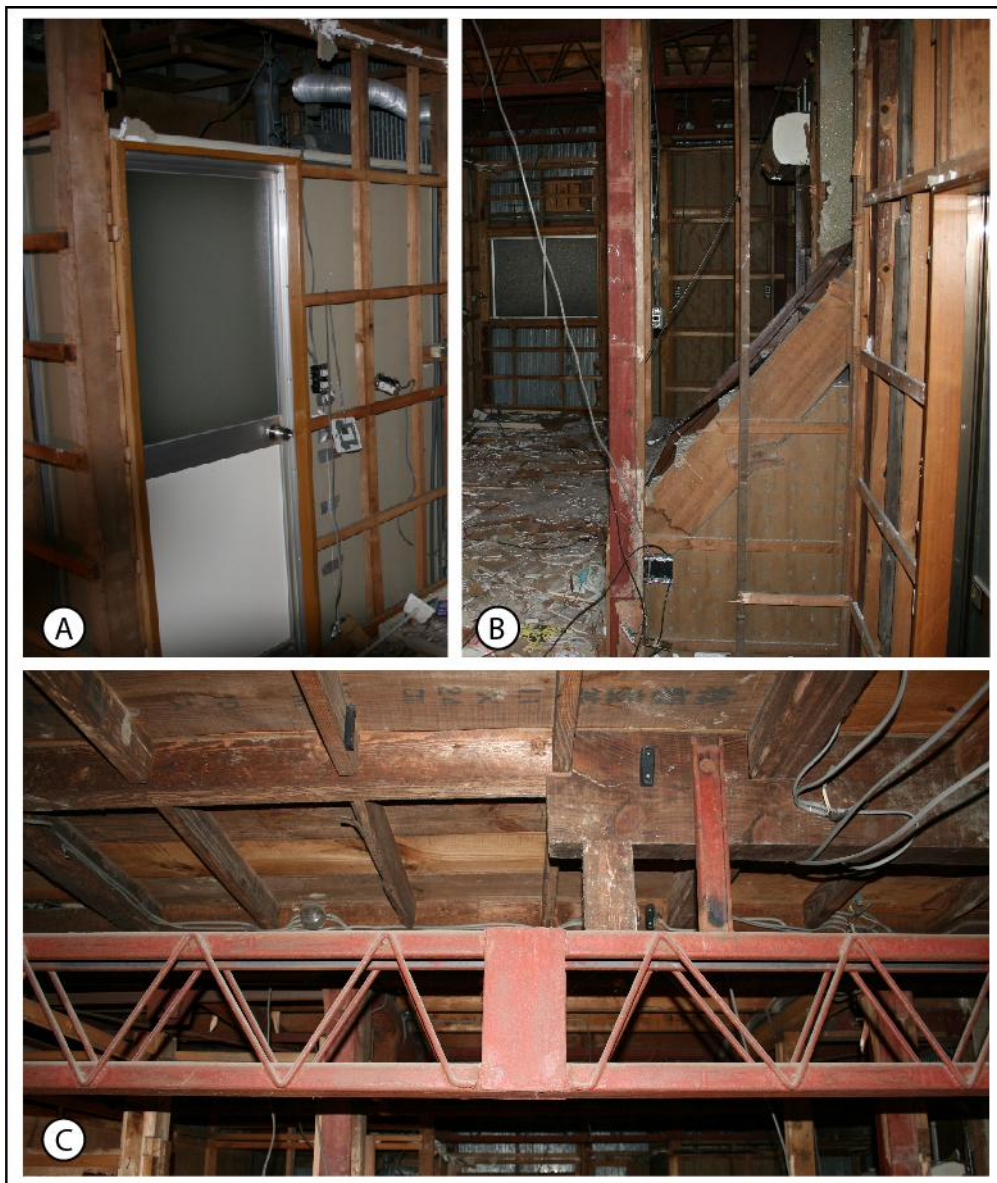
Fig. 8 Typical timber-frame structure house, which has been reinforced by a metallic structure during the Showa period (1926-1989). We can also appreciate the external wall panels made of painted steel. (Photos: C. Gomez, 2006)

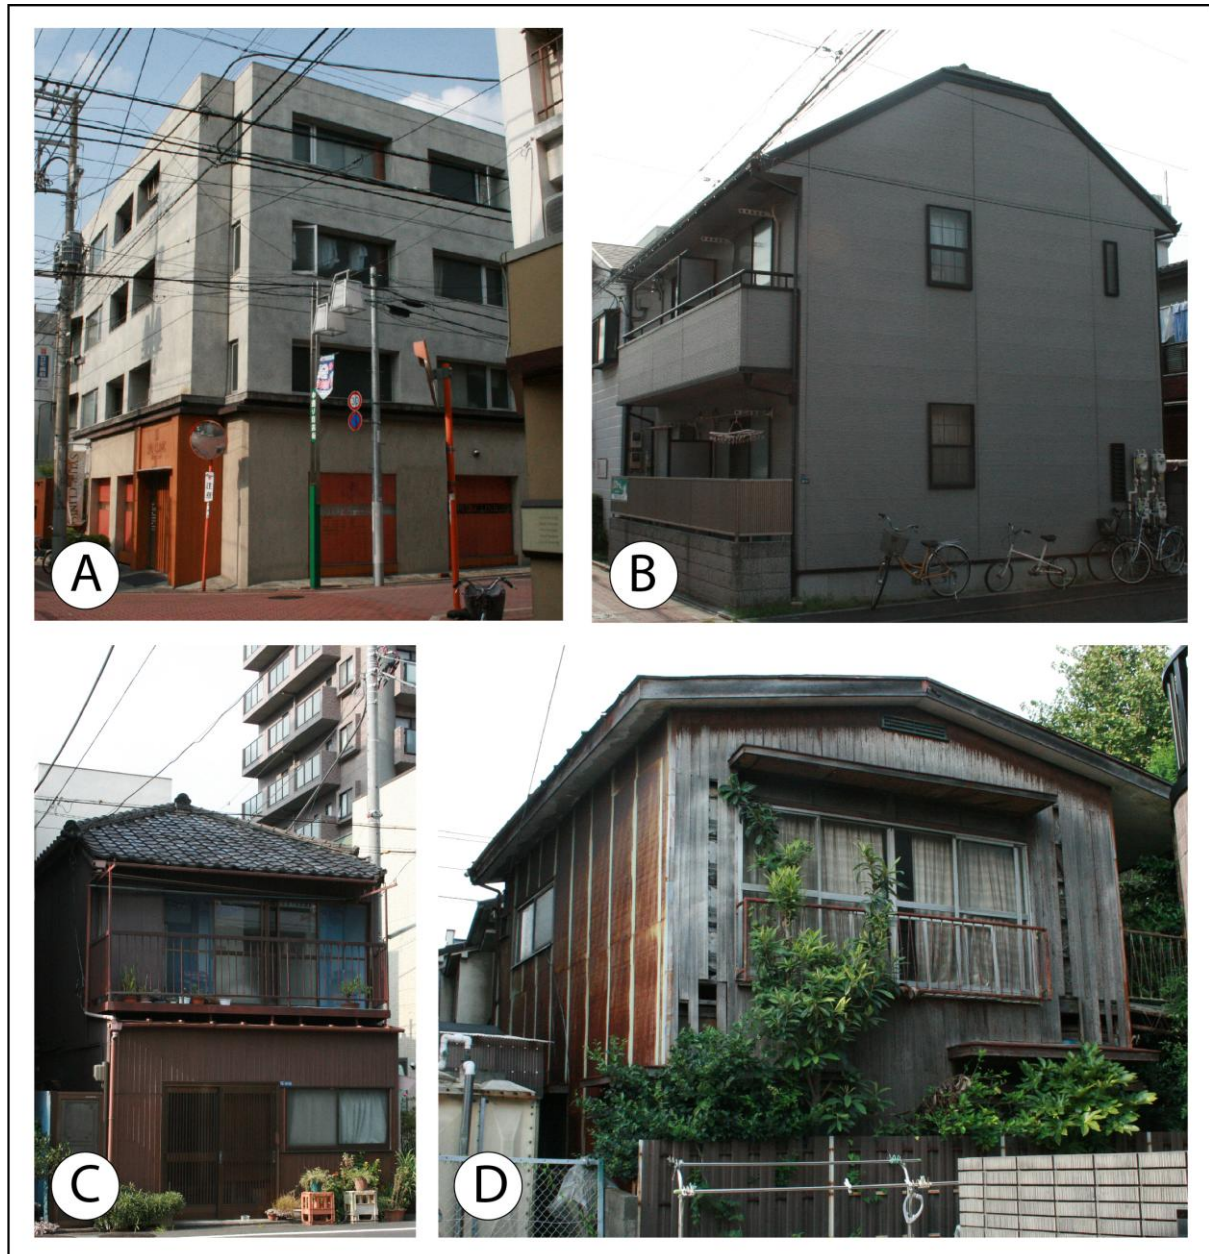
Fig. 9 Buildings' external walls: (A) Concrete building; (B) Wood panels covered by plastic sheets; (C) Aluminium sheets; (D) Traditional wood boards. (Photos: C. Gomez, 2007)
